ASSESSMENT OF MATERIAL DAMAGE OF BOILER DOWN-PIPES

A. KRAJCZYK, A. PSZONKA
and R. ŻUCHOWSKI (WROCLAW)

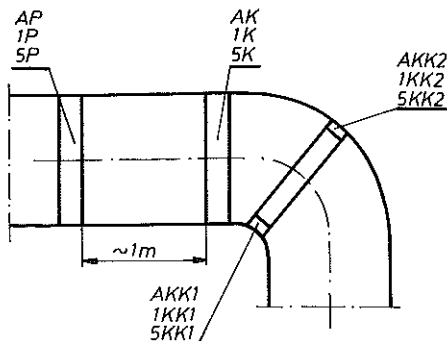
Fig. 1. Portion of down-pipe used in examination.

In the present paper the results of damage examination of down-pipes of 102mm diameter and 5mm wall thickness made of K18 steel (designation according to Polish Standards) are presented. These down-pipes were cut out of a failed boiler (type OR/32) in one of Polish power plants. The failure took place at the convex portion of the pipe bend (knee).

Two down-pipes that had worked during the period of 56749 h (designated 1 and 5) and a virgin one (designated A) were used in the investigation. Additional designation was also used. The specimens that were cut out from the portion in the vicinity of the pipe bend (knee) were denoted *K* while those cut out of the down-pipe portion located further from the knee were denoted *P*. The specimens that were cut out of the convex portion of the knee were denoted *KK2* while those cut out on the concave side were denoted *KK1*. Designations of specimens in dependence on their locations are shown in Fig.1.

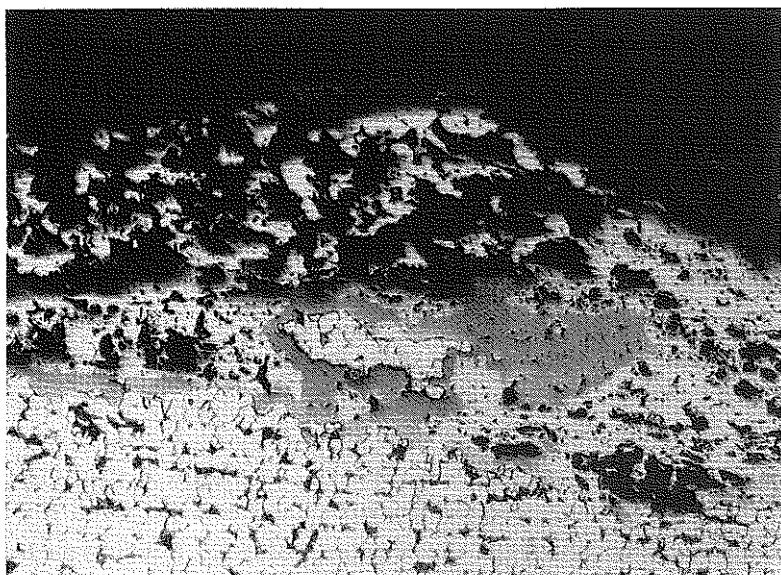
ling scale layers and corrosion products whose thickness reached 0.5mm. Visible irregularities were also found on internal surfaces of down-pipes. However, non-metallic layers accumulated on internal surfaces were different for both used and virgin down-pipes. Internal surfaces of virgin down-pipes were covered with annealing scale layers and corrosion products while for used down-pipes a tight intermediate layers have been observed between pipe surfaces and annealing scale layers. This intermediate layers of 0.1mm maximum thickness were formed as a result of interaction between steam and steel surface of down-pipes. Annealing scale layers on internal surfaces of down-pipes were covered with dust sediment. The different types of layers formed in service on internal surface of down-pipe are shown in Fig.3. The results obtained for specimens

Fig. 3. Different types of layers. Internal surface of used down-pipe. Magn. 200x.

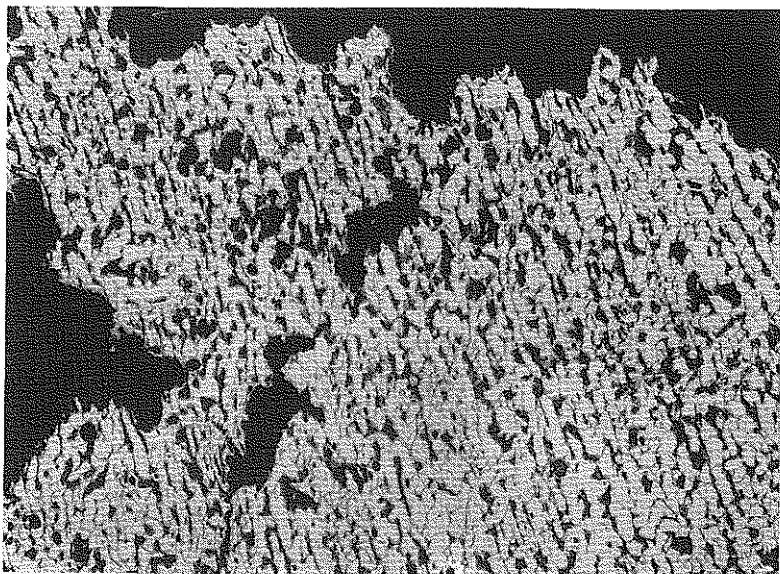
made of the portion of failed down-pipe were similar to those obtained for unfailed used down-pipes except for some cracks in the vicinity of fracture (Fig.4). Lack of sedimental and corrosion products inside these cracks shows that observed cracks can be considered due to failure.

Fig. 4. Cracks in the vicinity of fracture. Failed down-pipe. Magn. 200x.
